Port Authority of N.Y and N.J.
Litigation Sampling Program

Sample Area Data Sheet

Facility: World Trade Center Building: Tower 1

Description of Sampling Area: Elevator shafts' Zone I Local Cars.

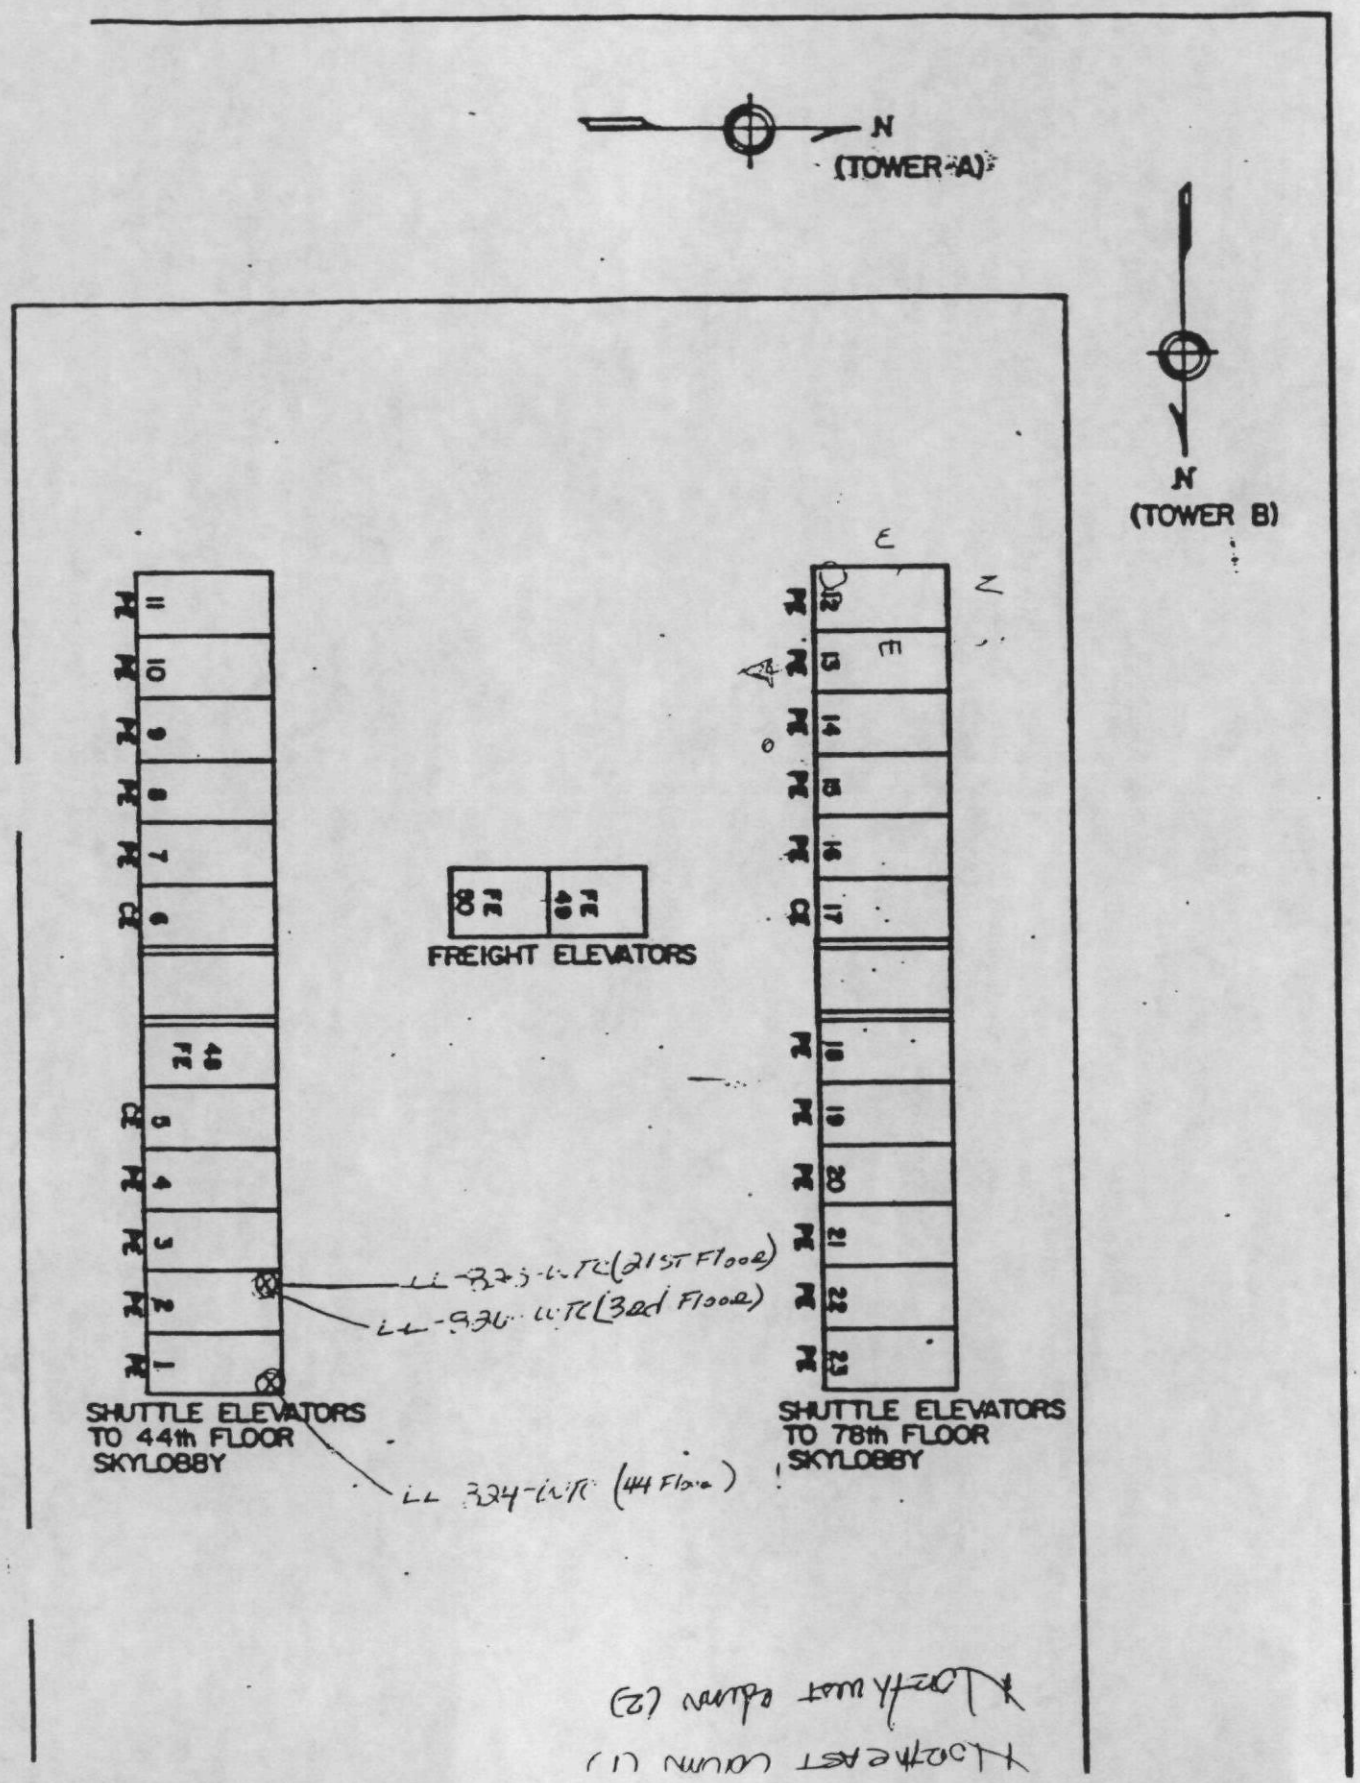
N
(TOWER A)
N
(TOWER B)
FREIGHT ELEVATORS
SHUTTLE ELEVATORS
TO 44th FLOOR
SKYLOBBY
SHUTTLE ELEVATORS
TO 78th FLOOR
SKYLOBBY
LL-323-WTC (21ST Floor)
LL-326-WTC (3rd Floor)
LL 324-WTC (44 Floor)
Northeast column (1)
Northwest column (2)

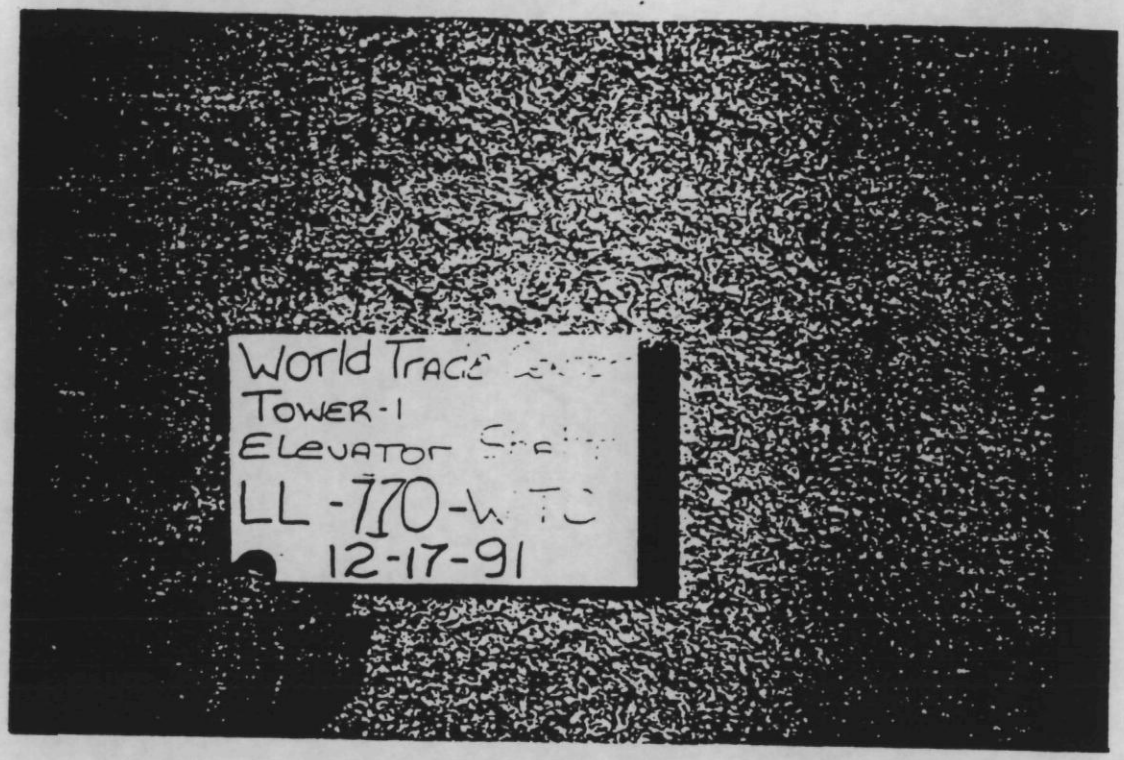
WORLD TRADE CENTER
TOWER-1
ELEVATOR SHAFT
LL-770-WTC
12-17-91

LE NUMBER	DESCRIPTION OF SAMPLING LOCATION
L-770-WTC	Spray-on fireproofing and hard coat encapsulant Sampled at the 76th floor off of car #22 from the column next to the entrance.

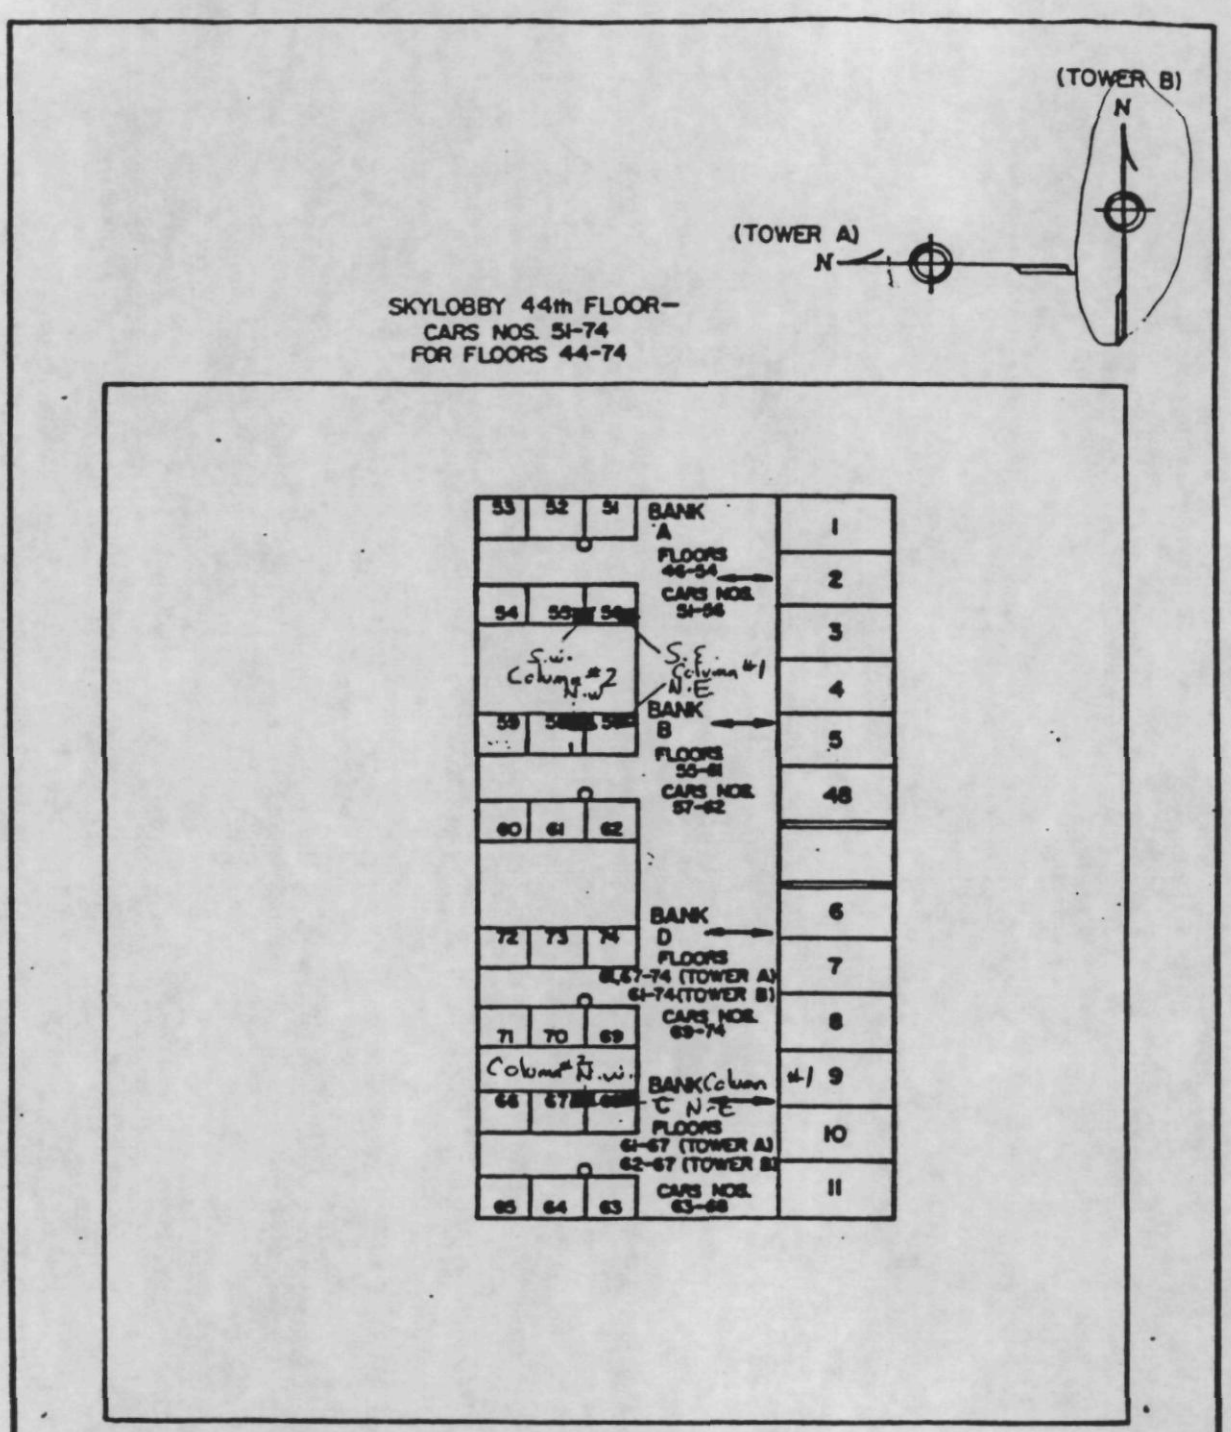
LE NUMBER	DESCRIPTION OF SAMPLING LOCATION
LL-831-WTC	Spray-on fire proofing & Encapsulant mat'l Sampled from a (52") I-column Samples collected from the 54th floor, column 10*2, CAR pe-56
LL-832-WTC	Spray-on fireproofing & Encapsulant mat'l Sampled from a (52") I-column Samples collected from the 45th floor, column 10*1, CAR pe-56

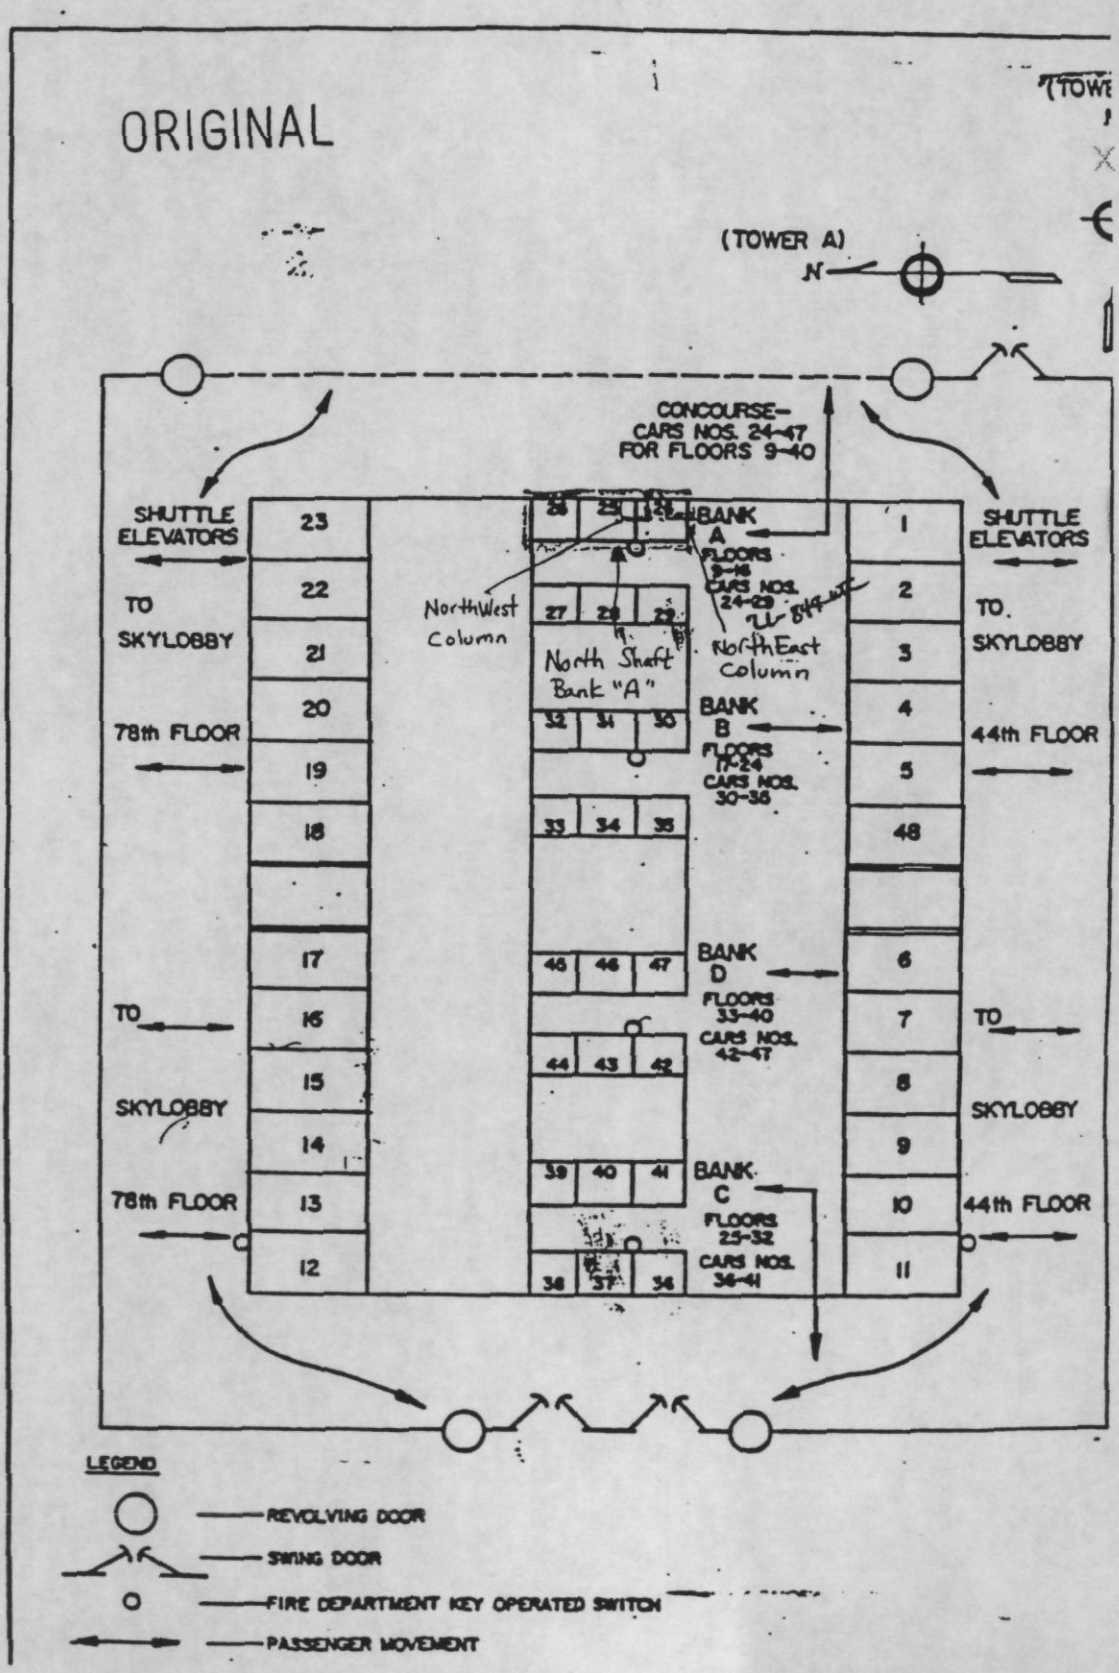
(TOWER A)
N
CONCOURSE-
CARS NOS. 24-47
FOR FLOORS 9-40
SHUTTLE ELEVATORS
TO SKYLOBBY
78th FLOOR
TO
SKYLOBBY
78th FLOOR
TO
SKYLOBBY
44th FLOOR
TO
SKYLOBBY
44th FLOOR
23
22
21
20
19
18
17
16
15
14
13
12
1
2
3
4
5
48
6
7
8
9
10
11
BANK A
FLOORS 9-16
CARS NOS. 24-29
BANK B
FLOORS 17-24
CARS NOS. 30-36
BANK D
FLOORS 33-40
CARS NOS. 42-47
BANK C
FLOORS 25-32
CARS NOS. 36-41
North West Column
North East Column
North Shaft Bank "A"
LEGEND
REVOLVING DOOR
SWING DOOR
FIRE DEPARTMENT KEY OPERATED SWITCH
PASSENGER MOVEMENT

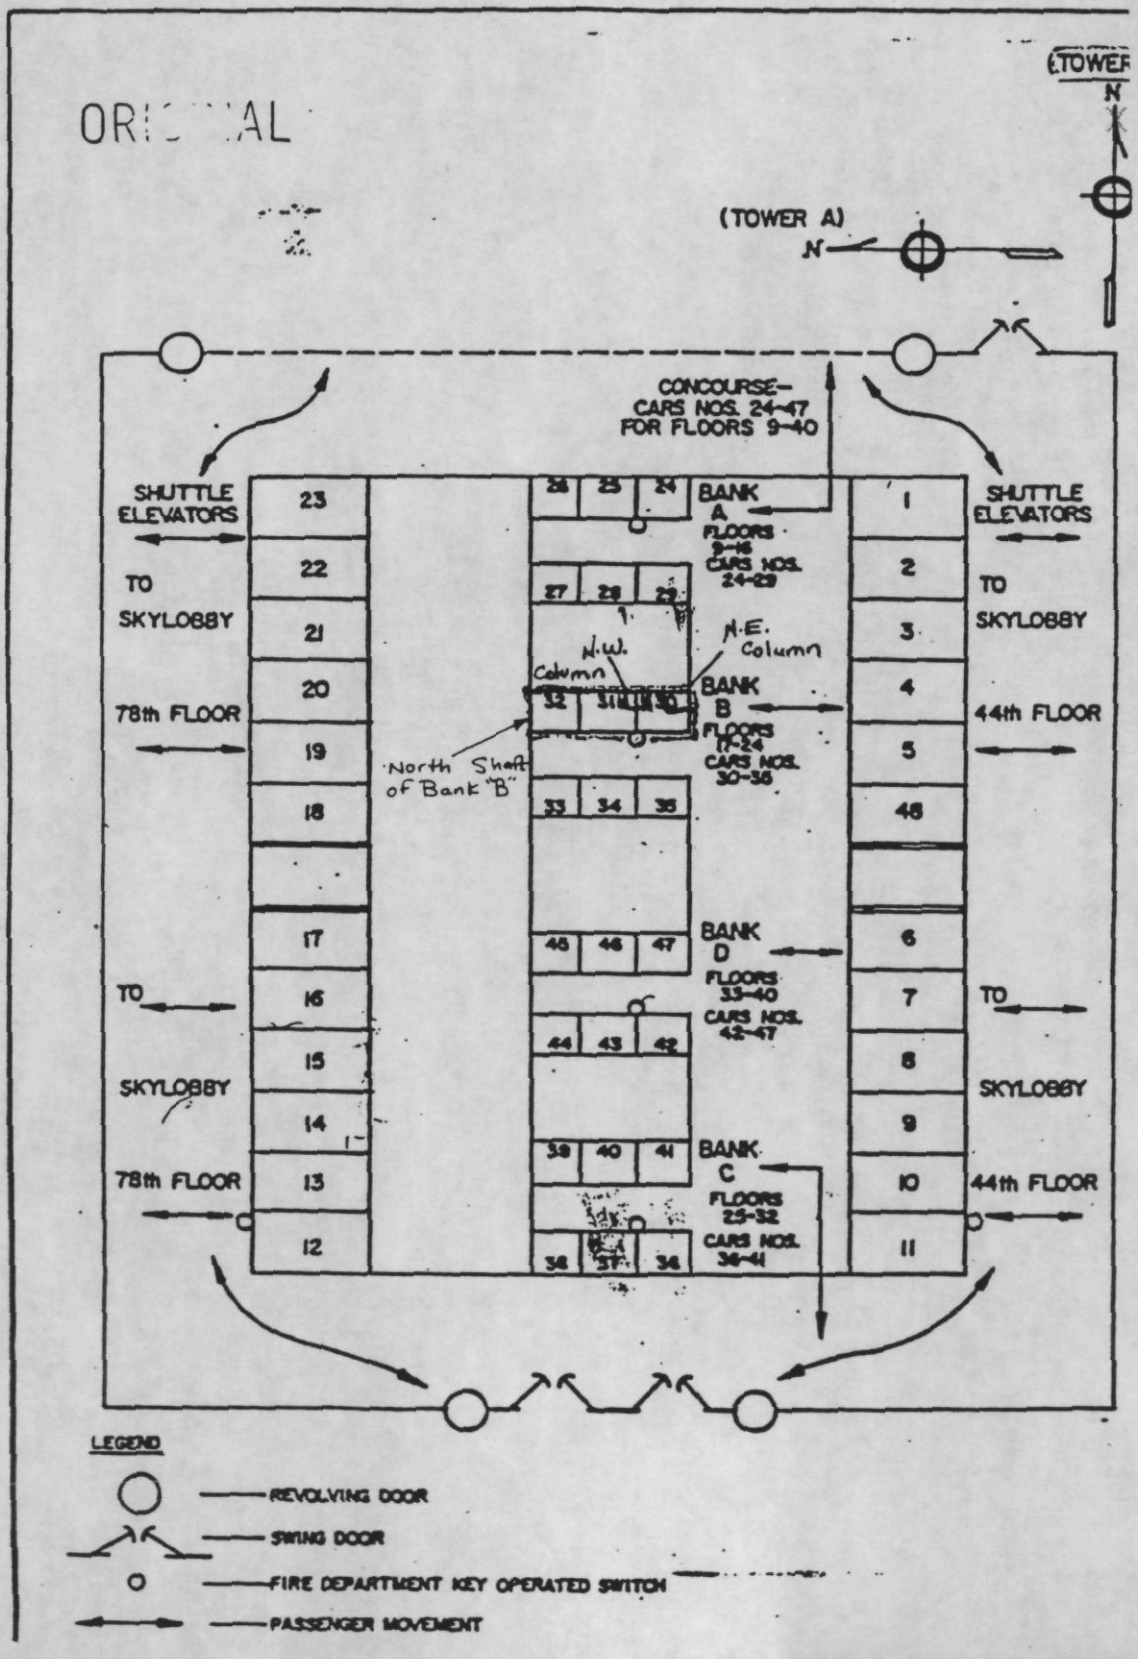
ORIGINAL
(TOWER A)
N
CONCOURSE-
CARS NOS. 24-47
FOR FLOORS 9-40
SHUTTLE ELEVATORS
TO SKYLOBBY
78th FLOOR
44th FLOOR
BANK A
FLOORS 9-16
CARS NOS. 24-29
BANK B
FLOORS 17-24
CARS NOS. 30-35
BANK C
FLOORS 25-32
CARS NOS. 36-41
BANK D
FLOORS 33-40
CARS NOS. 42-47
N.W. Column
N.E. Column
North Shaft of Bank "B"
LEGEND
REVOLVING DOOR
SWING DOOR
FIRE DEPARTMENT KEY OPERATED SWITCH
PASSENGER MOVEMENT

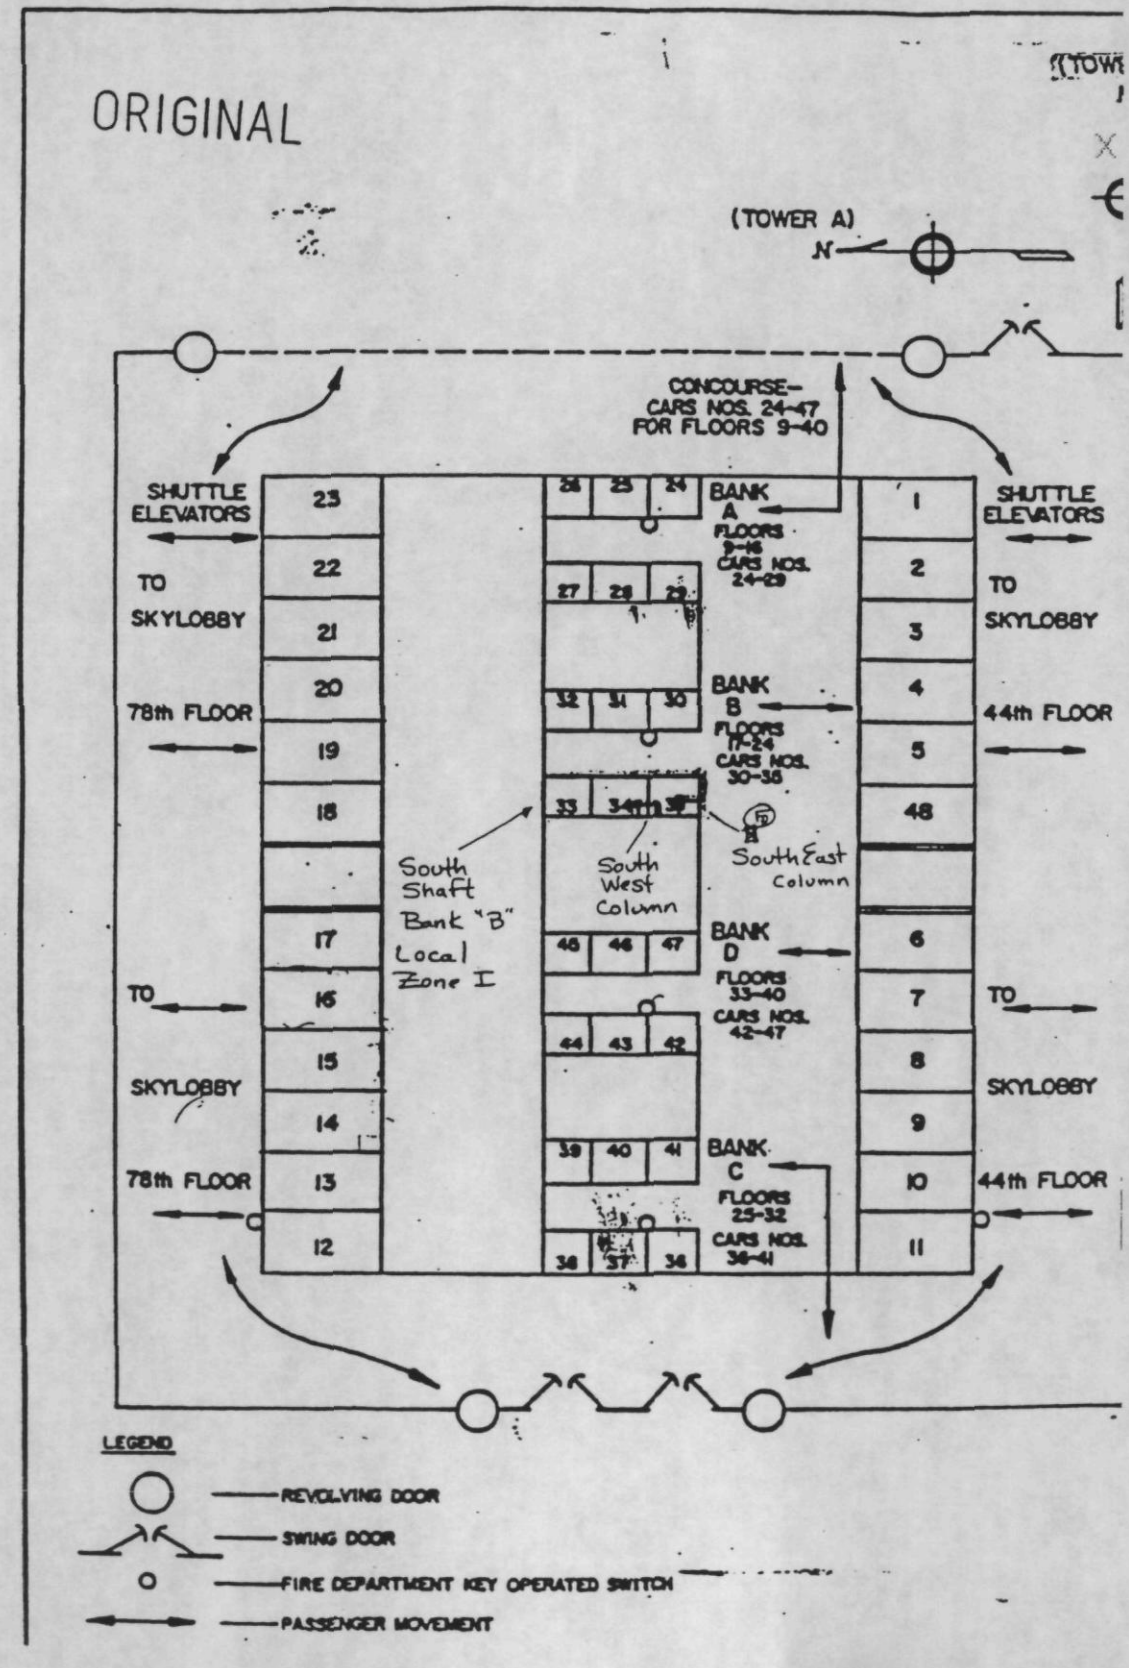
ORIGINAL
(TOWER A)
N
CONCOURSE–
CARS NOS. 24-47
FOR FLOORS 9-40
SHUTTLE
ELEVATORS
TO
SKYLOBBY
78th FLOOR
TO
SKYLOBBY
78th FLOOR
23
22
21
20
19
18
17
16
15
14
13
12
BANK
A
FLOORS
9-16
CARS NOS.
24-29
BANK
B
FLOORS
17-24
CARS NOS.
30-35
BANK
D
FLOORS
33-40
CARS NOS.
42-47
BANK
C
FLOORS
25-32
CARS NOS.
36-41
South
Shaft
Bank "B"
Local
Zone I
South
West
Column
South East
Column
SHUTTLE
ELEVATORS
TO
SKYLOBBY
44th FLOOR
TO
SKYLOBBY
44th FLOOR
1
2
3
4
5
48
6
7
8
9
10
11
LEGEND
REVOLVING DOOR
SWING DOOR
FIRE DEPARTMENT KEY OPERATED SWITCH
PASSENGER MOVEMENT
